REPORT NUMBER **K35**

CHELSWORTH CONSERVATION AREA APPRAISAL

conservation area appraisal

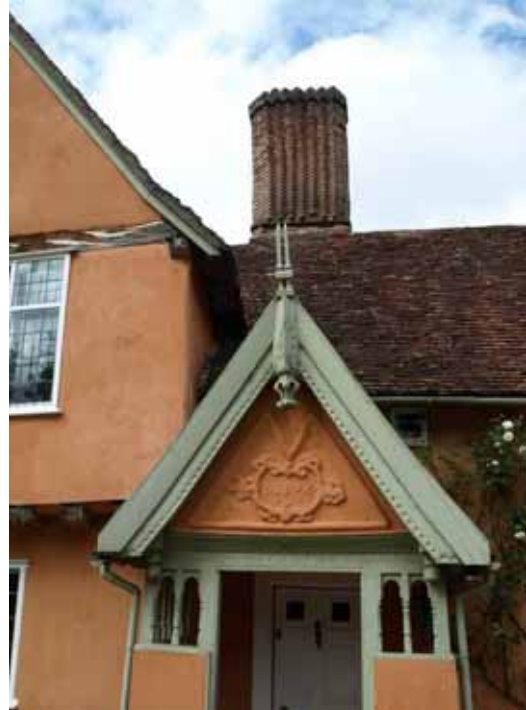
The Grange near the Church is a 15th Century timber-framed and plastered hall house with a plaintile roof. It has crosswings at the north and south ends and there are a number of later 17th Century additions including an interesting gabled porch dated 1689.

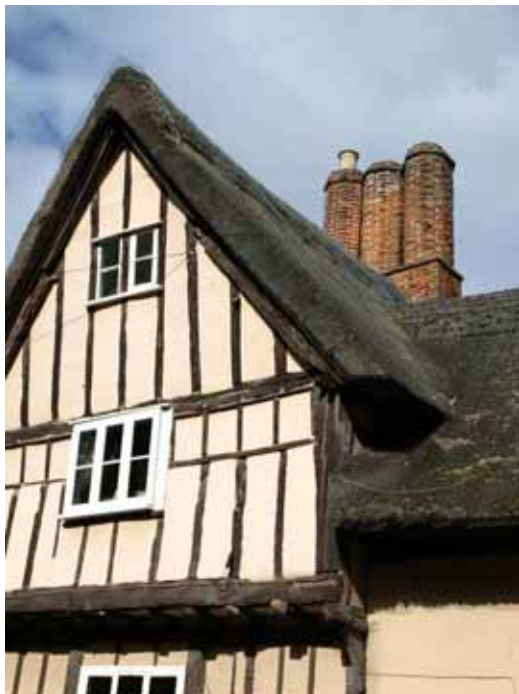
The Old Forge on The Street is of similar age but has exposed timber-framing and a thatched roof. It has a 16th Century central chimney stack with octagonal brick shafts and inside a good 16th Century fireplace.

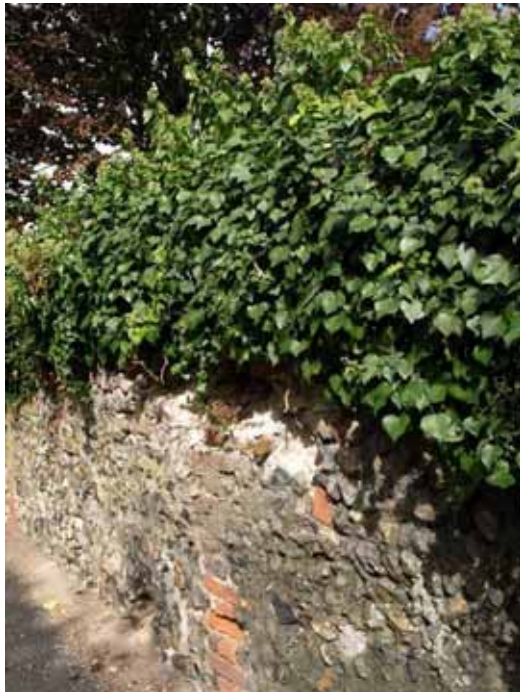
One small section of flint walling near the central double bend in The Street is in need of some sympathetic repair.
