HMS GANGES SHOTLEY GATE SUFFOLK

Integrated Ecology, Heritage and
Landscape Management Plan

Version Three

Related to application for:
Reserved Matters Planning Permission
for Proposed Residential Development

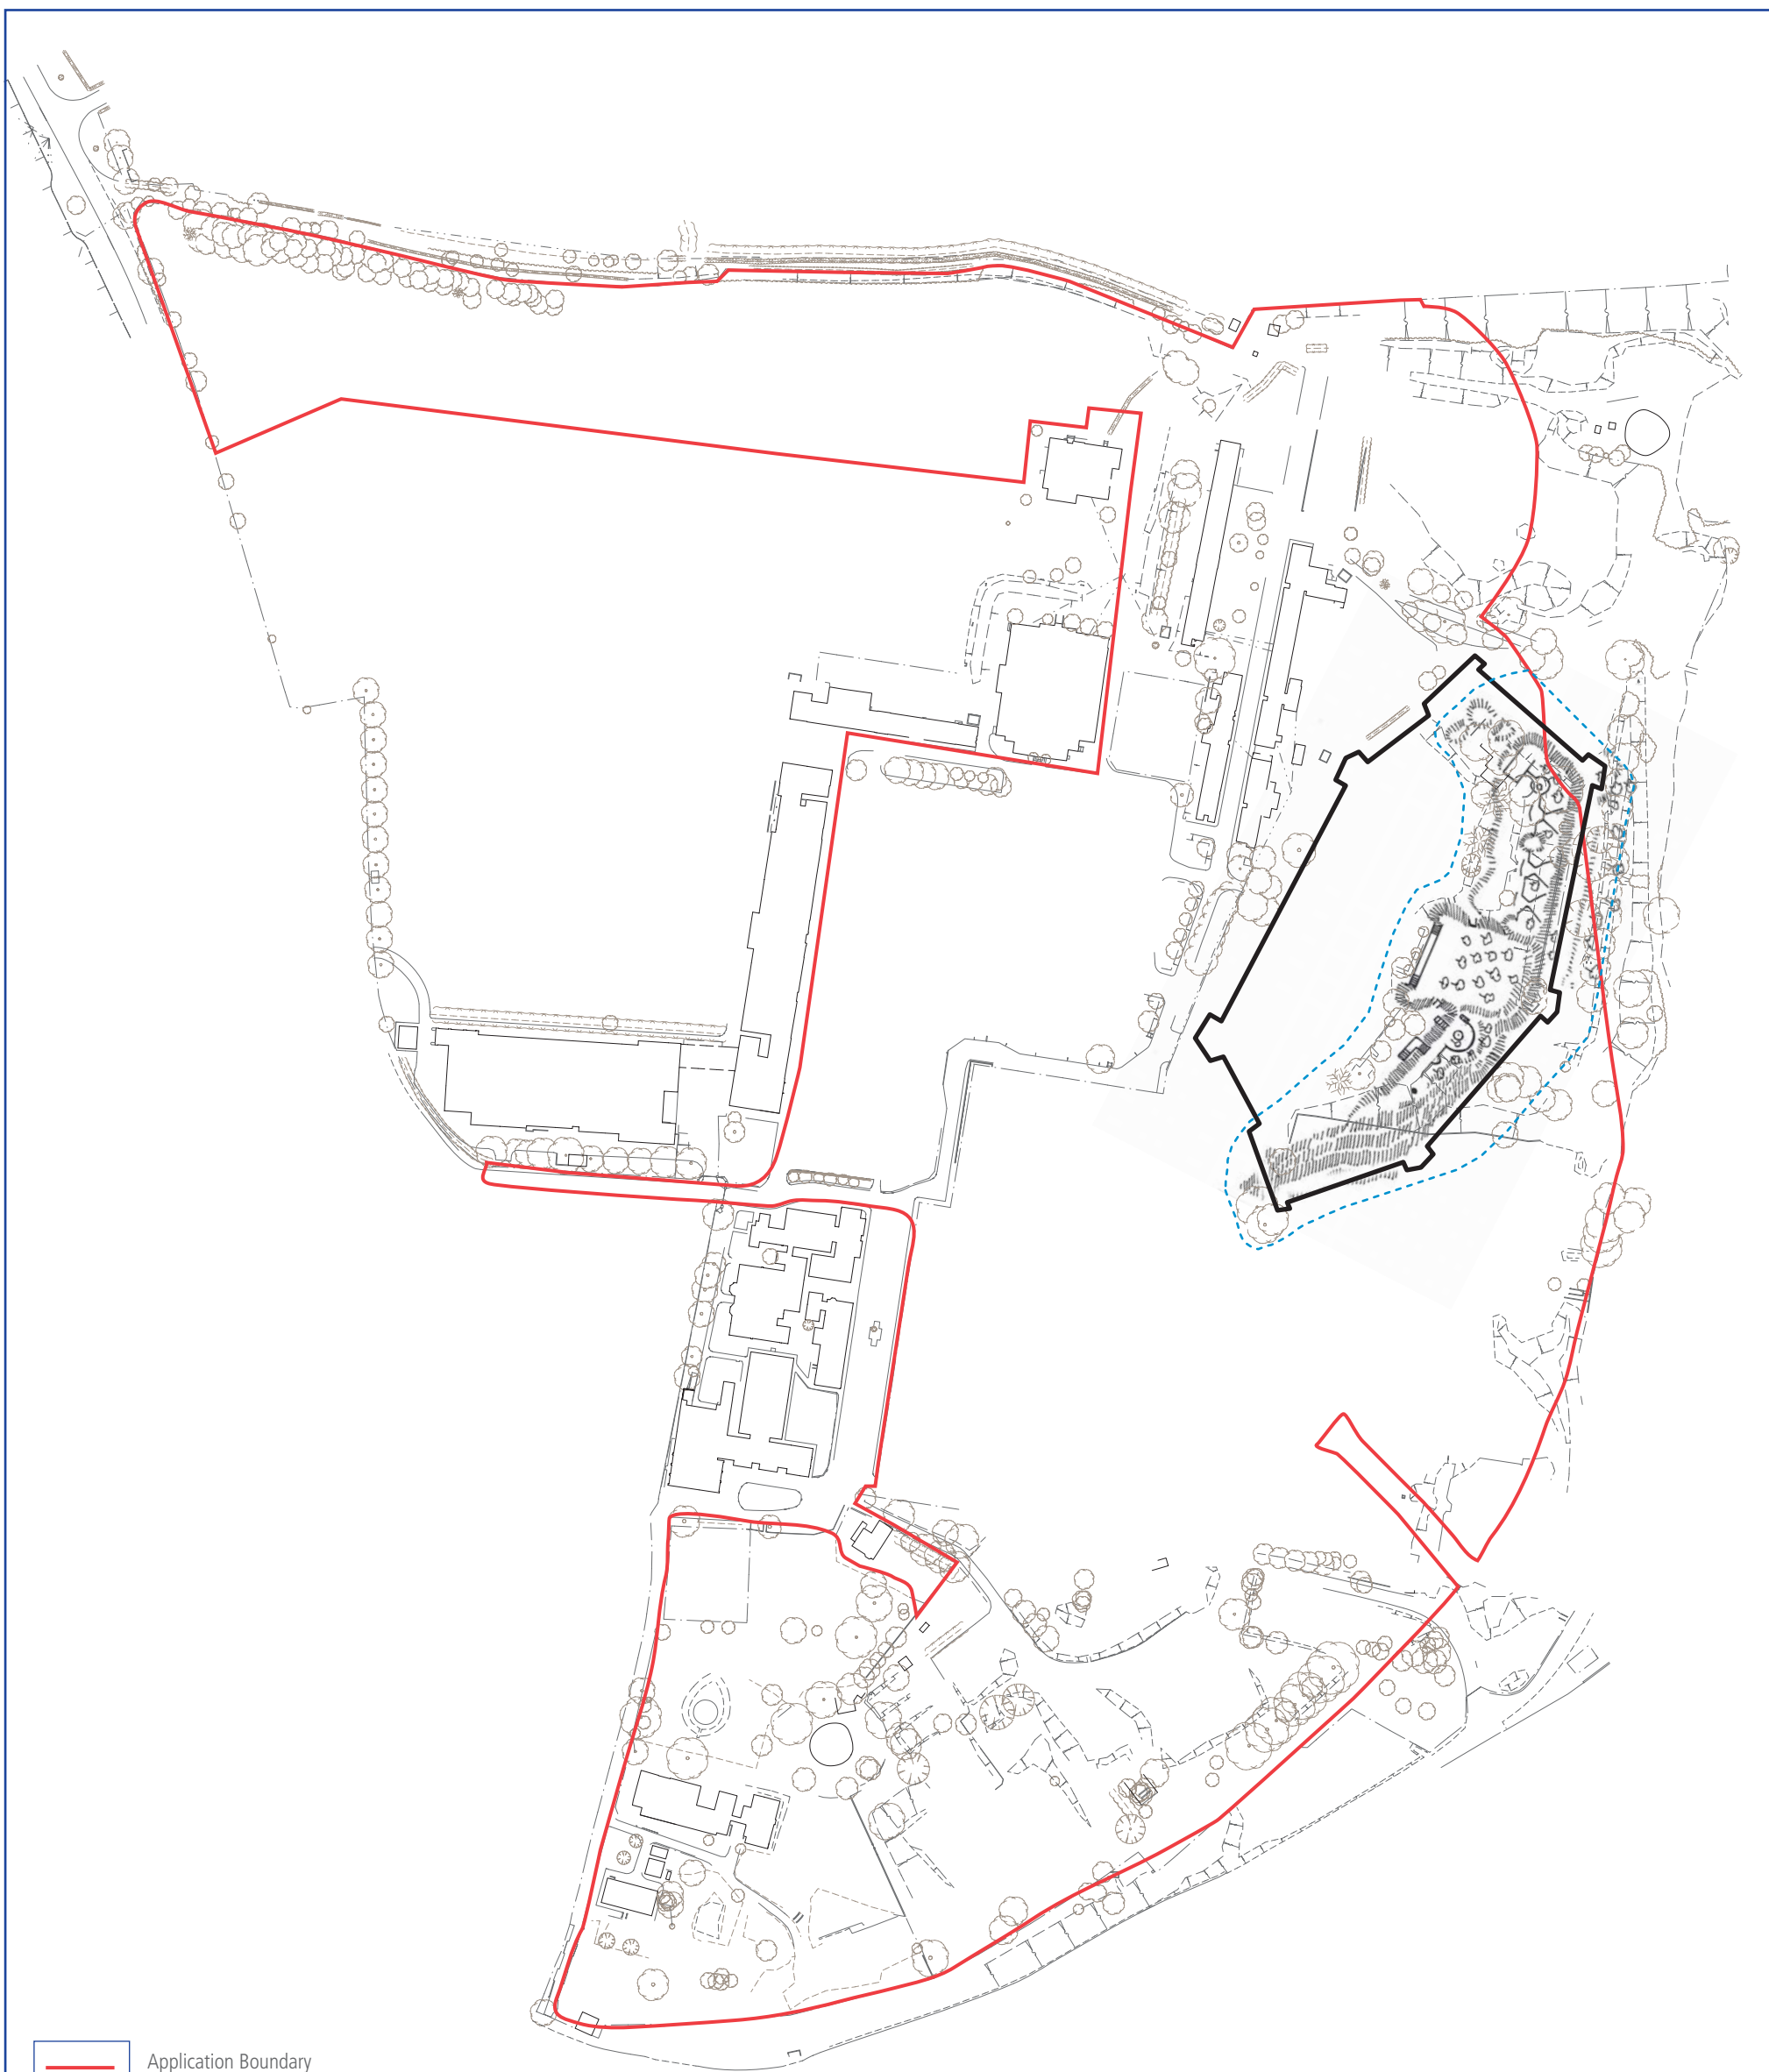
The development site boundary is shown in **Figure 1** below.

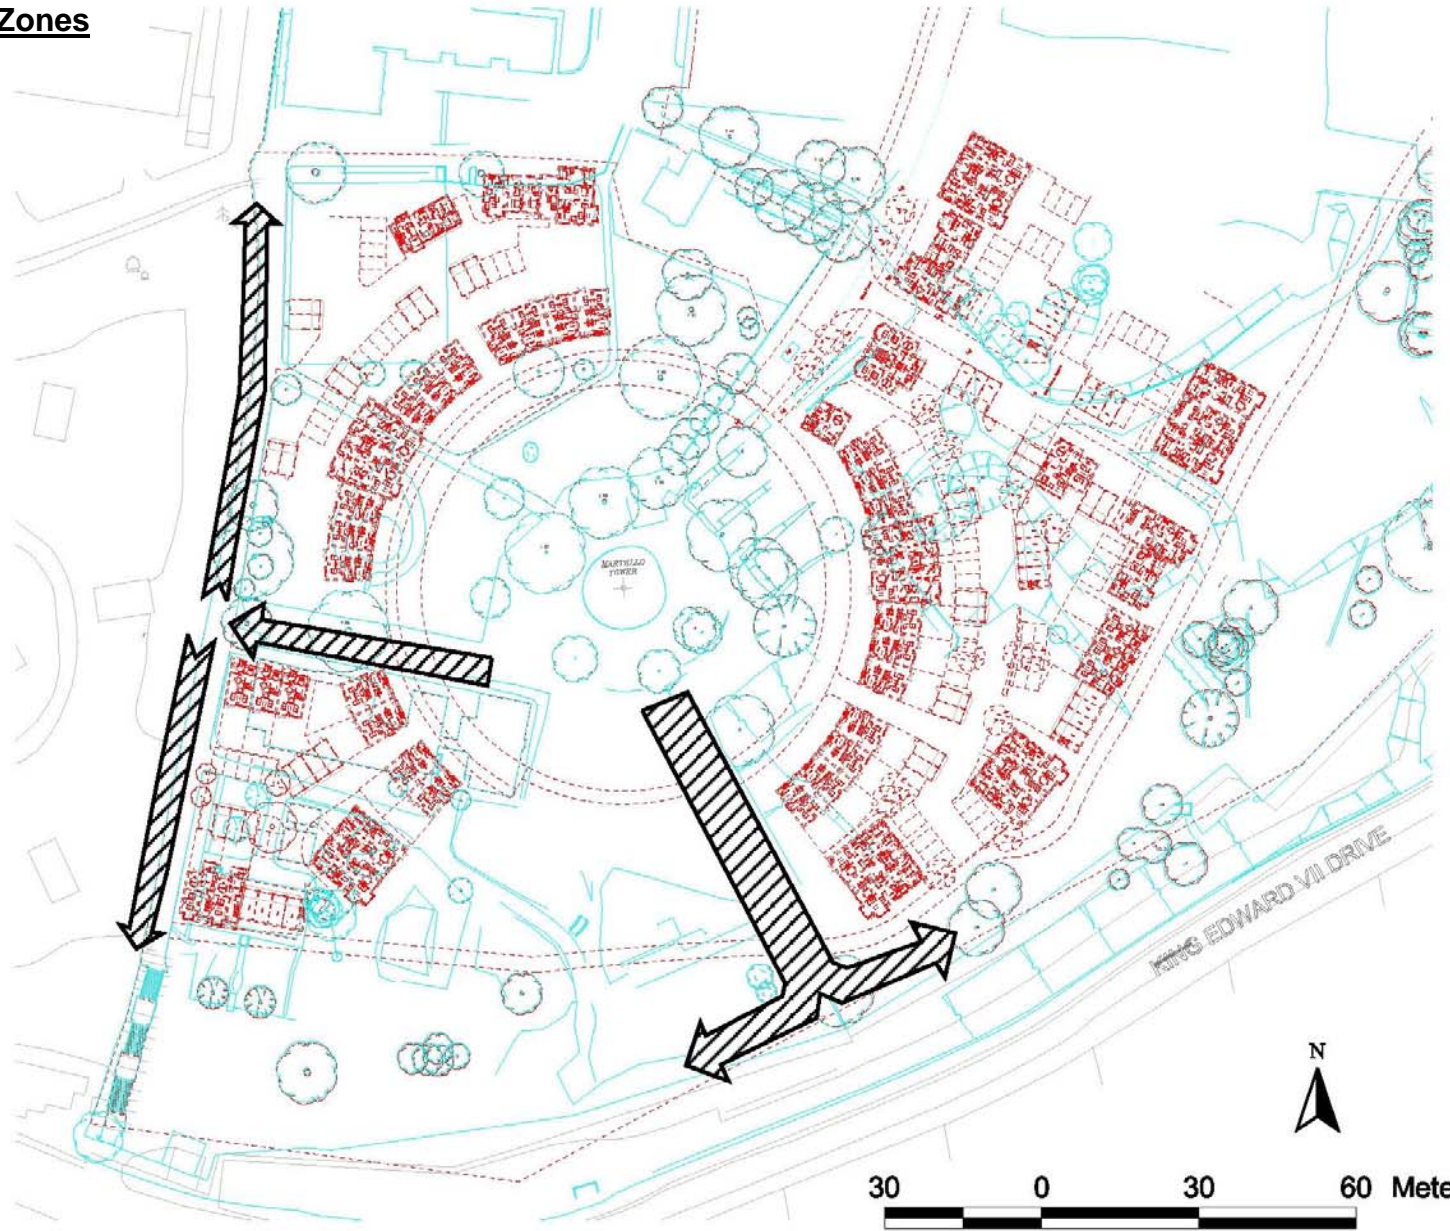
Existing site layout
-   Bat flight zone

- 1 Stabilize Tower. Address defects. Enhance environment for bats, monitor conditions and bats. No lighting of Tower. Secure Tower's external openings retaining bat access.
- 2 Clear debris and ruderals around Moat and glacis and expose original moat brickwork. Plant insect-supporting shrubs with non-invasive roots around border. Landscape with rough grassland areas. Provide interpretation boards.
- 3 Plant new native tall trees and shrubs to connect to west boundary hedge. Maintain as dark, vegetated bat flight corridor.
- 4 Plant new native trees and shrubs southwards, sympathetic to views from the Tower, to provide a bat flight corridor connecting to the south and east boundary.
- 5 Retain existing trees, wherever possible, and erect bat boxes on suitable mature trees within bat flight areas near the Tower.
